**Meadowbrook Heights Second Subdivision
Loveland, CO**

Report #: 51593-0
Beginning: July 1, 2025
Expires: June 30, 2026

RESERVE STUDY
"Full"

March 22, 2024

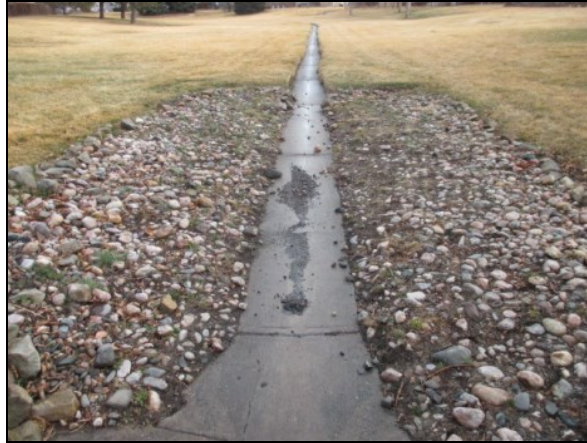
Comp #: 21070 Concrete Gutters - Repair - 5%

Comments: Concrete gutters determined to be in fair condition typically may start to exhibit minor hair-line cracks. Although there is no predictable expectation for total replacement within the scope of this study we suggest a rotating funding allowance to supplement the operating budget for periodic larger-scale repair/replacement. Best to time larger repairs with asphalt seal coat cycles when possible for cost efficiency paint any curbs and fire lanes at that time as well.

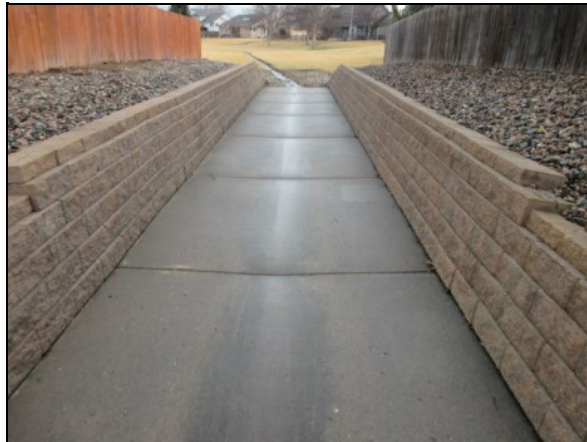
Comp #: 21080 Concrete Swales/Pans - Repair - 5%

Comments: The concrete swales and pans were observed to be in fair condition. Minor cracking was noted at the time of the inspection. No heavy damage was seen. Concrete swales are important elements of the site drainage system. Should be inspected periodically to ensure that drainage is not interrupted and any significant cracks or damaged sections repaired in order to maintain a smooth surface. Plan on replacing the swales at the same time as the asphalt removal.

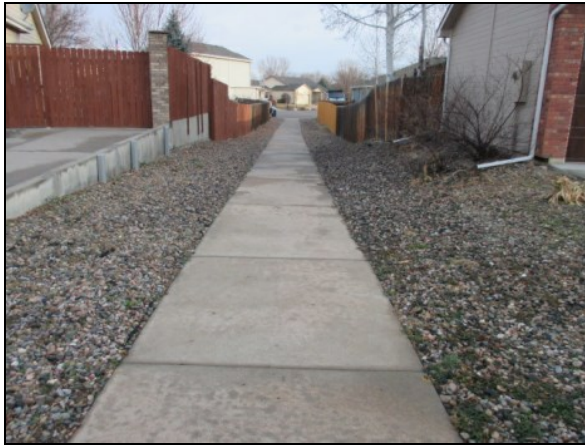
Comp #: 21090 Concrete Walkways - Repair - 5%

Comments: Concrete sidewalks determined to be in fair condition typically exhibit minor changes in slope and a moderate percentage of cracking and surface wear. Trip hazards may be increasing in frequency and severity and should be closely monitored to prevent further risks. The Rocky Mountain Region is home to expansive soils. One of the causes of concrete damage in this type of climate is soil moisture. Expansive soils tend to swell in size when wet and contract as they dry out. As the soil expands and contracts it can create enough force to cause major damage to sidewalks. Repair any trip and fall hazards immediately to ensure safety. As routine maintenance inspect regularly pressure wash for appearance and repair promptly as needed to prevent water penetrating into the base and causing further damage. In our experience larger repair/replacement expenses emerge as the community ages. Although difficult to predict timing cost and scope we suggest a rotating funding allowance to supplement the operating/maintenance budget for periodic larger repairs. Adjust as conditions actual expense patterns dictate within future reserve study updates.

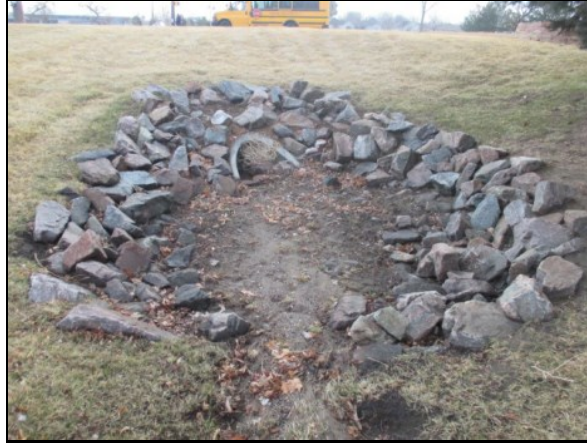
Comp #: 21100 Site Drainage System - Clean/Repair

Comments: No access to inspect in-ground drainage infrastructure. Annual preventive maintenance work is typically performed as part of an client's general maintenance/operating fund. Under normal circumstances site drainage components are constructed of very durable materials which should have a very long useful life (often assumed to be 50 years or more). Repairs may occasionally be required but timing and scope of work is too unpredictable for Reserve funding in accordance with National Reserve Study Standards. If there are specific known concerns with drainage system we recommend further investigation using cameras or other means to document and identify conditions. Some clients consult with civil and/or geotechnical engineers in order to develop scopes of work for repair/replacement. If more comprehensive analysis becomes available findings should be incorporated into Reserve Study updates as appropriate.

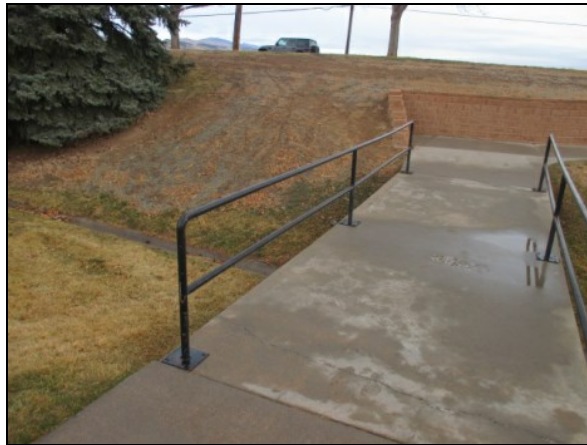
Comp #: 21300 Site Rail: Metal - Repair/Paint

Comments: Metal fencing determined to be in poor condition typically exhibits more advanced deterioration of coating or surface finish with notable wear possibly including corrosion and rust. In advanced cases coating may be flaking or peeling away to expose metal structure. Poor curb appeal. Metal fencing should be painted at the interval shown here in order to inhibit or delay onset of rust/corrosion and prevent or minimize costly repairs. Painting not only protects the metal surface from excessive wear but promotes a good attractive appearance in the common areas. Costs can vary greatly depending on existing conditions of fencing which will dictate amount of repair/prep work required.

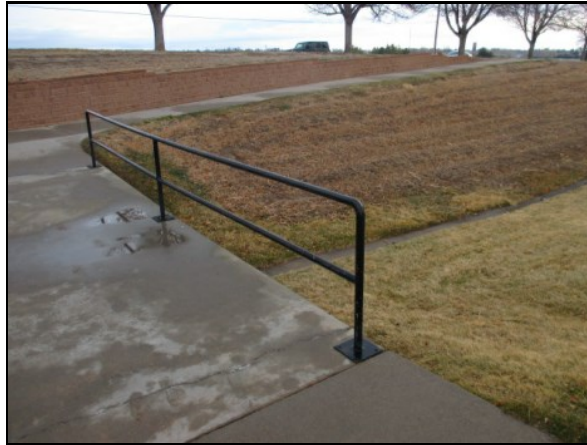
Comp #: 21310 Site Rail: Metal - Replace

Comments: Metal railing determined to be in poor condition typically exhibits more advanced or extensive surface wear and other signs of age, which may include damaged or vandalized sections, loose or missing hardware and other obvious concerns. At this stage, fencing is often an eyesore and replacement from an aesthetic standpoint should be considered, even if fencing is still technically upright and intact. In our experience, metal fencing will typically eventually break down due to a combination of sun and weather exposure, which is sometimes exacerbated by other factors such as irrigation overspray, abuse and lack of preventive maintenance. For some types of fencing, complete replacement is advisable over recoating or refinishing due to relatively short lifespan of coatings and consideration of total life-cycle cost.

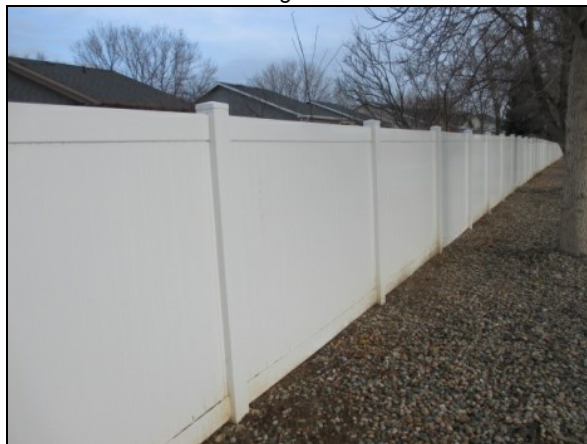
Comp #: 21350 Site Fencing: Vinyl - Replace

Comments: Fencing determined to be in fair condition typically exhibits some surface wear warping fading and/or chalking. May also exhibit some loose or missing panels and possibly minor leaning or damage. Overall appearance is consistent but declining. As routine maintenance inspect regularly for any damage and repair as needed from Operating budget pressure-clean as a general maintenance item or along with larger building projects not as separate Reserve item. Even with proactive maintenance plan to replace at roughly the time frame below due to damage/deterioration that will result from constant exposure.

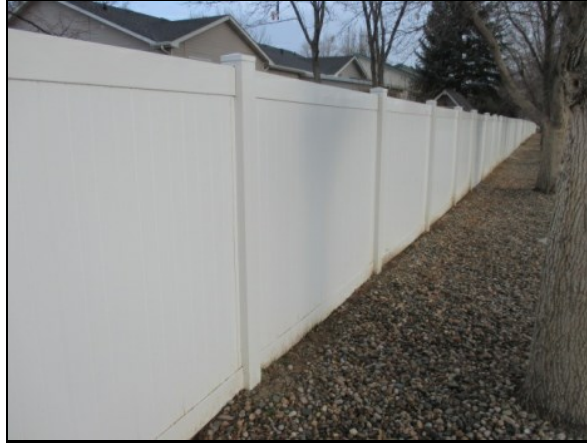
Comp #: 21350 Site Fencing: Vinyl - Replace (50%)

Fencing determined to be in fair condition typically exhibits some surface wear, warping, fading, and/or chalking. May also exhibit some loose or missing panels, and possibly minor leaning or damage. Overall appearance is consistent but declining. As routine maintenance, inspect regularly for any damage and repair as needed from Operating budget pressure-clean as a general maintenance item or along with larger building projects, not as separate Reserve item. Even with proactive maintenance, plan to replace at roughly the time frame below due to damage/deterioration that will result from constant exposure.

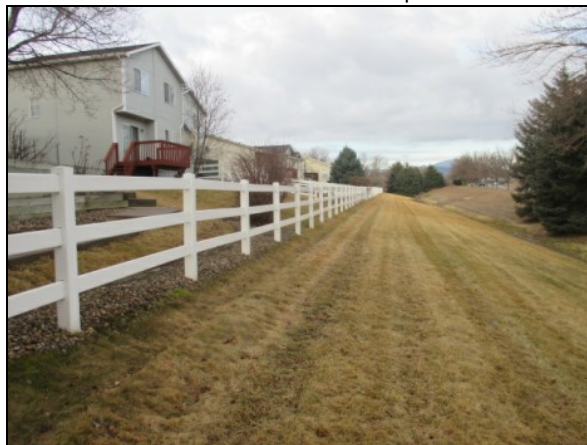
Comp #: 21350 Site Fencing: Vinyl Rail - Replace

Comments: The remaining useful life was slightly extended based on the appearance of the fence. Fencing determined to be in fair condition typically exhibits some surface wear, warping, fading, and/or chalking. May also exhibit some loose or missing panels, and possibly minor leaning or damage. Overall appearance is consistent but declining. As routine maintenance, inspect regularly for any damage and repair as needed from Operating budget pressure-clean as a general maintenance item or along with larger building projects, not as separate Reserve item. Even with proactive maintenance, plan to replace at roughly the time frame below due to damage/deterioration that will result from constant exposure.

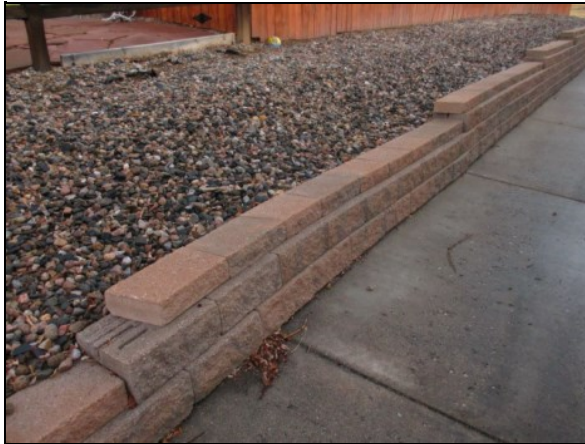
Comments: Our limited Analysis of a retaining wall is beyond the scope of a reserve study. If problems including shifting leaning or cracking are observed or suspected consult with an engineer (structural civil and/or geo-technical) for an evaluation and repair recommendations. There were no reported problems at this time.

No information was provided to us concerning how the retaining wall was designed or constructed. Observation of drainage was not possible. Proper drainage on the uphill side prevents a backlog of water (water if present can add substantial weight and pressure to the wall). A backlog of water if left unchecked could damage or break the wall. The interior of drainage lines (or pipes) can be viewed by video using a remote miniature camera. Clean out the drain lines as often as needed to prevent decreased drainage. Utilize a mobile evacuator service if needed. Inspect regularly and repair as needed using operating funds.
